Manhole Inspection Summary

Manhole # S07EE2003MH

Location Address: **6110 RUSK AVE**

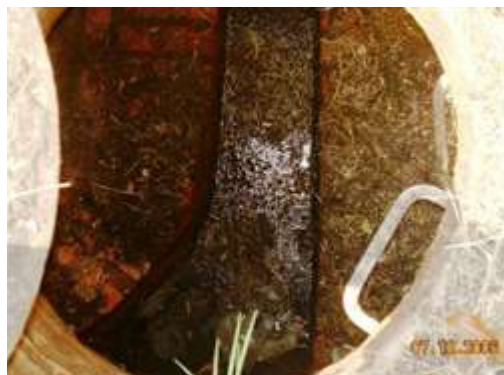
Top View

Comments **Standing water in the Channel.**

Condition: ☐ Sound ☐ Cracked ☐ Root Intrusion ☐ Deteriorated ☐ Leaks ☒ **Debris**

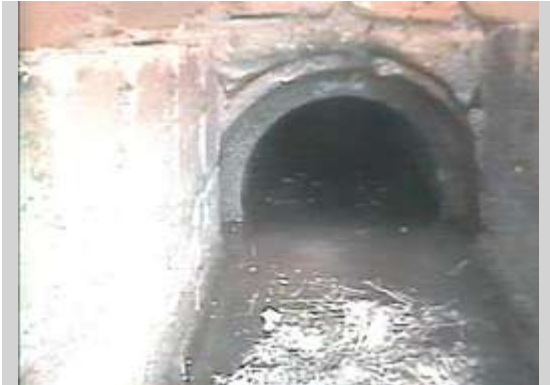
8 in. Circular Gravity Sewer Pipe Out @ 12 O'Clock

Infiltration: **Evidence** Pipe Seal Cond: **Unknown**

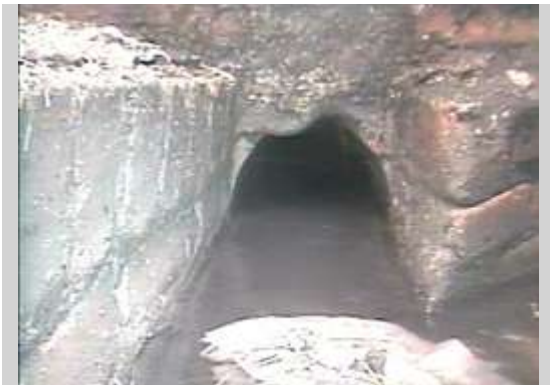
8 in. Circular Gravity Sewer Pipe In @ 6 O'Clock

Infiltration: **Evidence** Pipe Seal Cond: **Unknown**

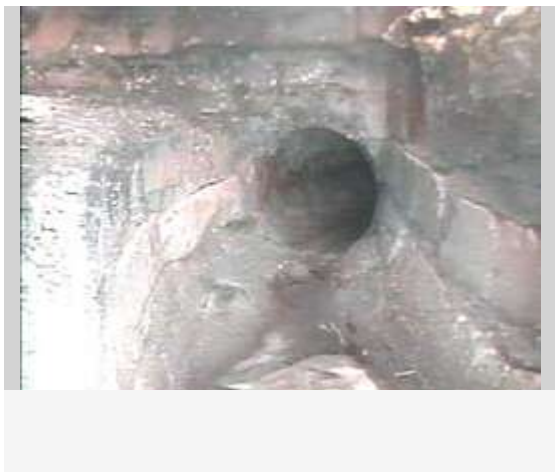
6 in. Circular Gravity Sewer
Pipe In @ 7 O'Clock

Infiltration: **Evidence** Pipe Seal Cond: **Unknown**
